**FEDERAL AVIATION ADMINISTRATION
AIRWORTHINESS DIRECTIVES
SMALL AIRCRAFT, ROTORCRAFT, GLIDERS,
BALLOONS, & AIRSHIPS**

BIWEEKLY 2007-04

AIRWORTHINESS DIRECTIVE

2003-17-05R1 Short Brothers & Harland Ltd.: Amendment 39-14946; Docket No. FAA-2006-25926; Directorate Identifier 2000-CE-17-AD.

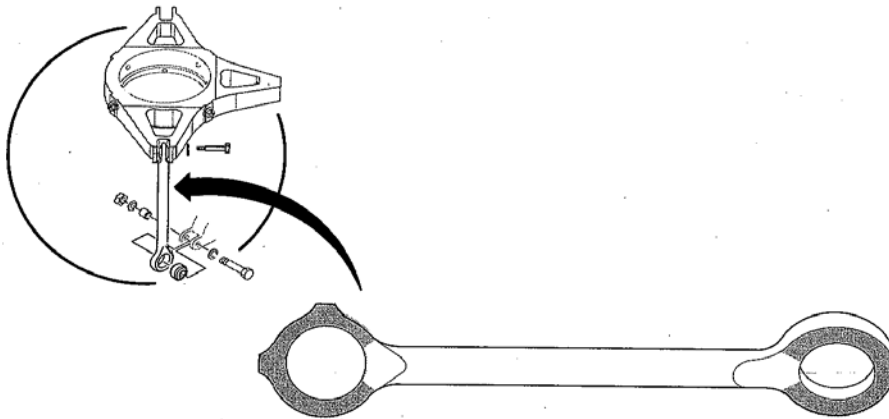
Figure 1

This Emergency Airworthiness Directive (AD) is prompted by the discovery of a cracked lateral mixer output link assembly (mixer link), part number (P/N) 600N7636-1, on an in-service MDHI Model MD600N helicopter. Cracks were also found on two additional mixer links, P/N 600N7636-3, which were being held as spares. The cracks on all three mixer links run through the bearing end area of the mixer link and emanate from staking marks in the mixer link. Cracks in the mixer link, if not detected, could result in failure of the mixer link and subsequent loss of control of the helicopter.

(1) Remove each mixer link and visually inspect, with a bright light and a 10x or higher magnifying glass, the shaded areas around the bearing bore for any crack as depicted in the following Figure 1:

Bearings have been removed for clarity.

(3) Replace any cracked mixer link with an airworthy mixer link on which an eddy current inspection has been performed.
